## Request for Determination of Applicability

### **BULGE AT PATTON INTERSECTION DEVENS, MA**

# Wetland Delineation Report

Bulge Rd & Patton Rd  
Devens, MA

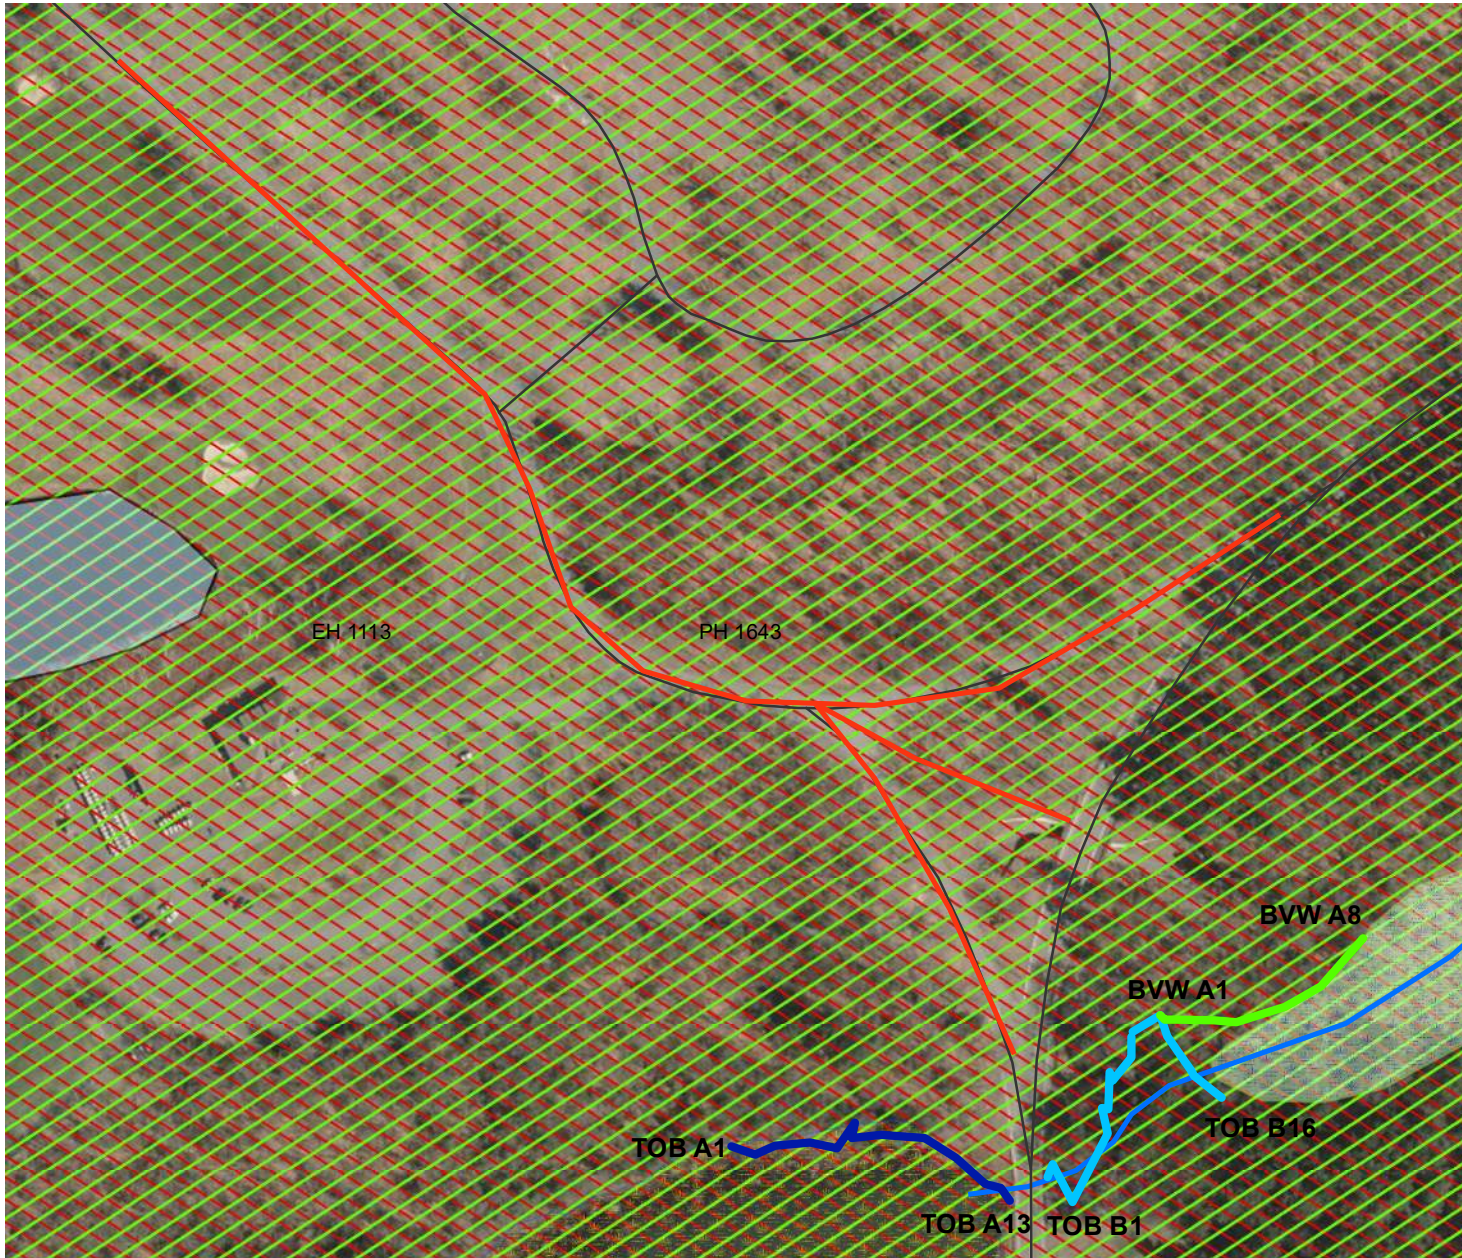
Wetland resources identified in the field were also added to these maps. Based on the MassGIS information, the entire site is located within NHESP Priority Habitat of Rare Species, and NHESP Estimated Habitat of Rare Wildlife.

Weston & Sampson created environmental resources maps (see Figure 4) of the site to determine the presence of other protected areas. The data source of these map layers was the Massachusetts Geographic Information System (MassGIS). These areas included:

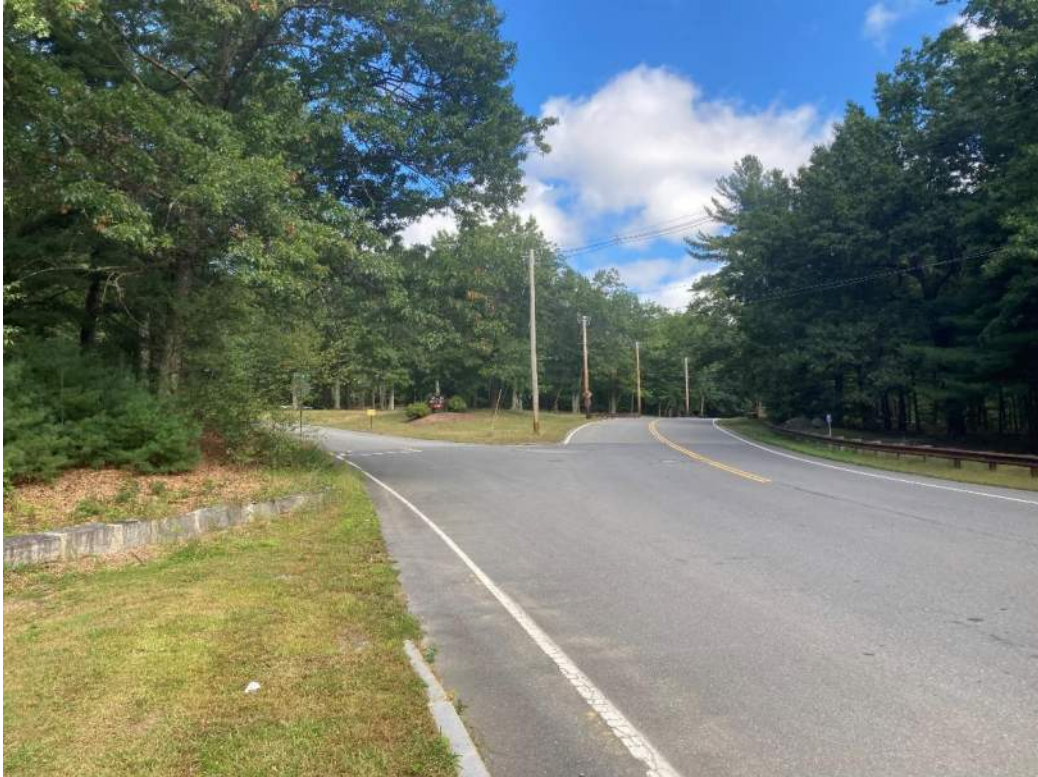
Photo 1: Bulge Road and Patton Road

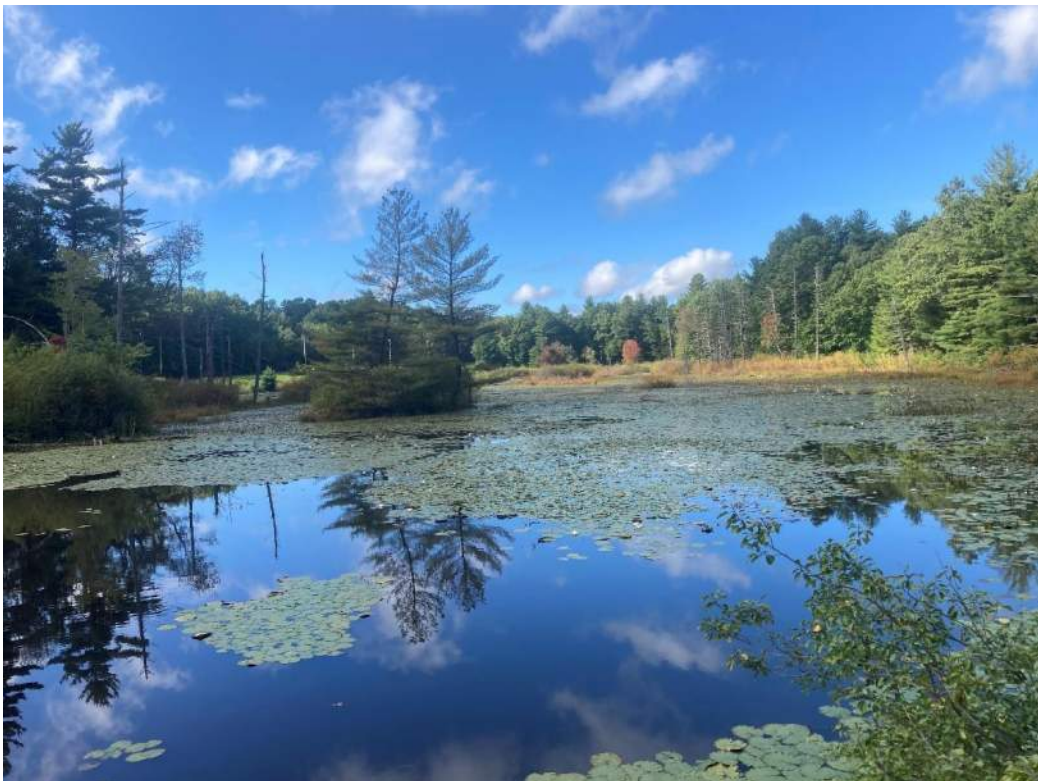
Photo 2: Unnamed Pond

A large unnamed body of standing water was identified within the investigation area. The unnamed waterbody is approximately 8.5 acres in size according to aerial imagery. Due to its size, the unnamed body of water is classified as a pond. According to the Massachusetts Wetland Protection Act a pond is defined as “any body of fresh water with a surface area observed or recorded within the last ten years of at least 10,000 square feet”. According to the Massachusetts Wetland Protection Act “ponds may be either naturally occurring or human made by impoundment, excavation or otherwise”. Wetland flags left in the field included:

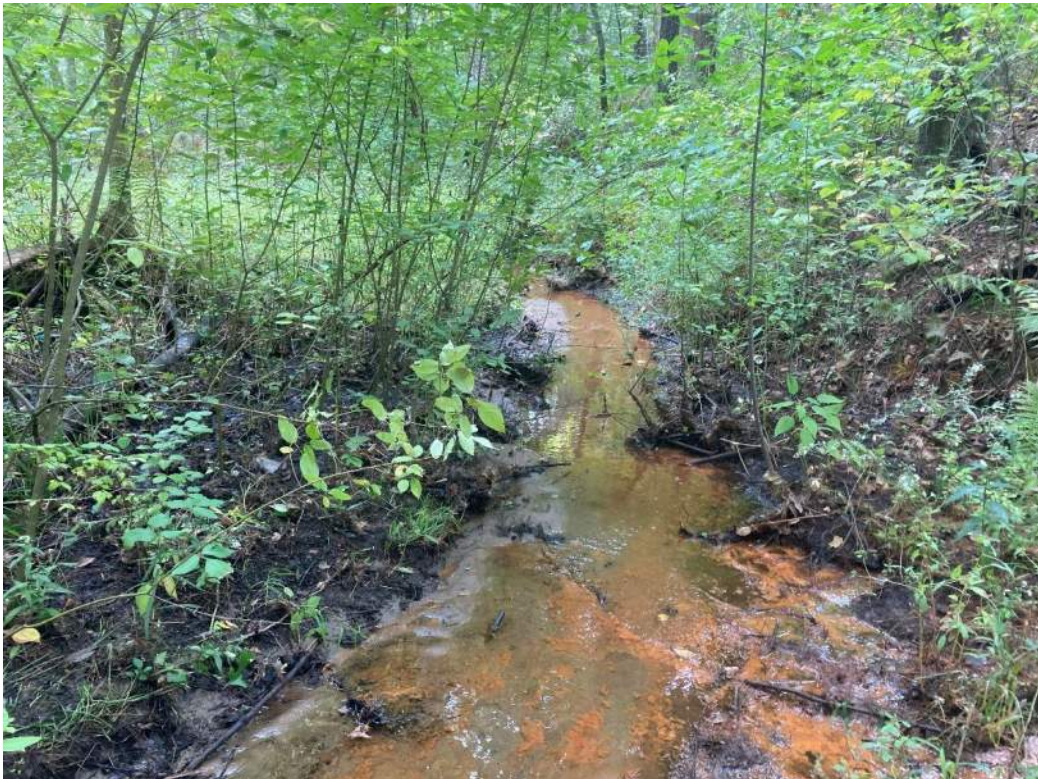
Photo 4: Cold Spring Brook

A single perennial stream known as Cold Spring Brook was identified within the investigation area. The boundary of the perennial stream was identified in the field utilizing Top of Bank (TOB), identified by flag line TOB-A. Cold Spring Brook is shown as perennial on the current United States Geographical Survey (USGS) map and has a watershed size greater than 0.5 square miles in size according to USGS Stream Stats which classifies the stream as perennial per 310 CMR 10.58 (2)(a)(1)(b-c). The boundary of the perennial stream was identified in the field by the first observable break in slope (TOB). Wetland flags left in the field included:

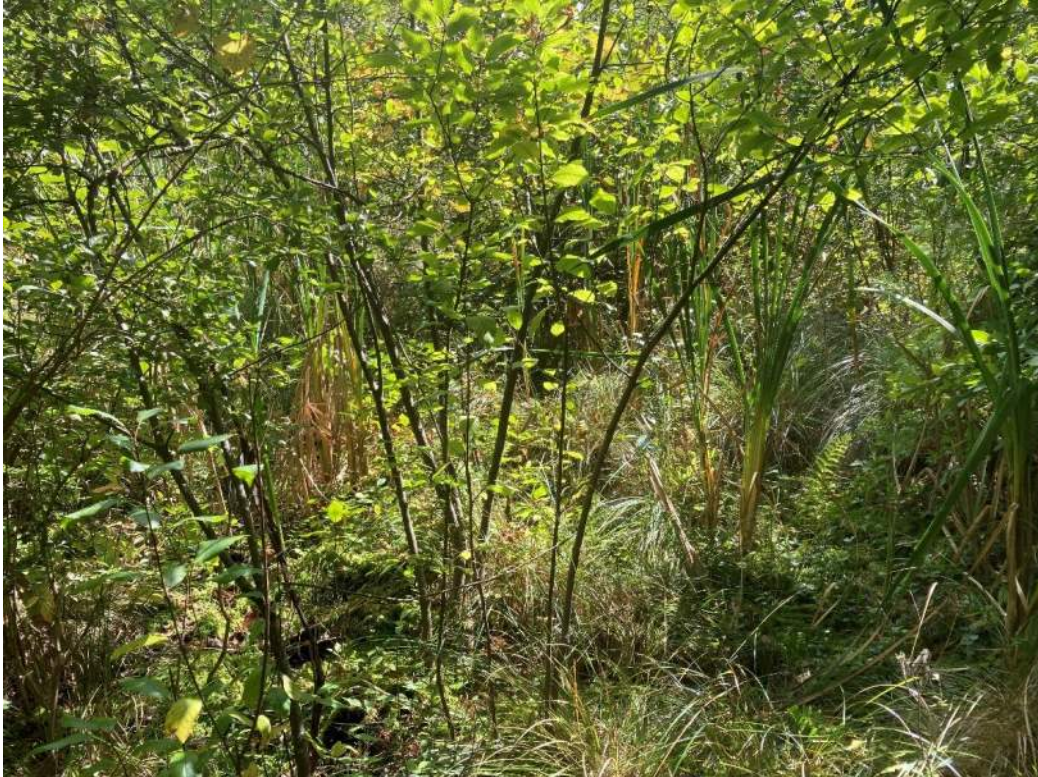
Photo 5: Bordering Vegetated Wetland (BVW A Series)

A single BVW series was delineated at the site. This BVW is located adjacent to Cold Spring Brook. The limit of the BVW resource areas were determined by locating the transitional area between wetland and upland vegetation, soils and hydrologic conditions. Wetland flags left in the field included:

Dominant vegetation within the wetland resource area included *Acer rubrum* (red maple), *Pinus strobus* (eastern white pine), *Vaccinium corymbosum* (highbush blueberry), *Frangula alnus* (glossy buckthorn), *Carex stricta* (tussock sedge), *Typha latifolia* (broadleaf cattail), *Osmundastrum cinnamomeum* (cinnamon fern), and *Osmunda regalis* (royal fern) species that generally thrive in wet conditions. Soils within the BVW's were composed of a thick organic layer underlain by fine sandy loam with redoximorphic features. Other indicators of wetland hydrology included surface water, highwater table and saturation.

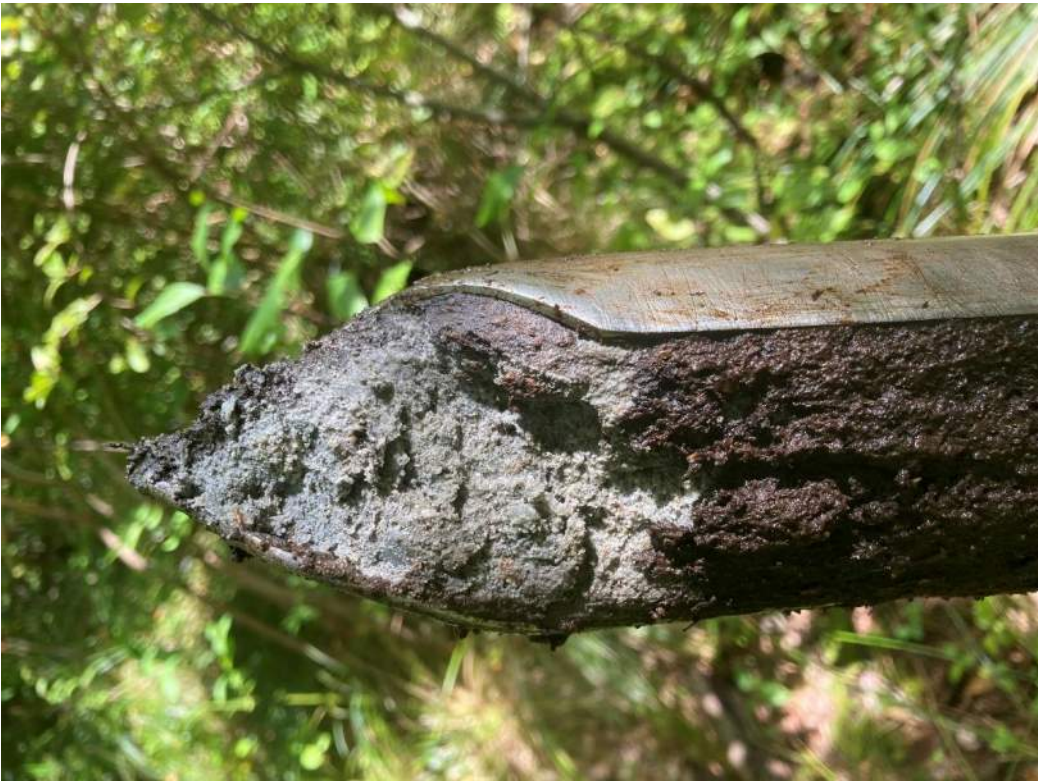
Photo 6: Wetland Soil Observed

A soil sample from each wetland sample plot is also taken. Each soil sample goes to a depth of at least 12-24 inches. The soil is characterized to determine if the soil sample is considered a hydric (wetland) soil. Soil samples, including mottles, are characterized based on color using Munsell Soil-Color charts as a color reference.

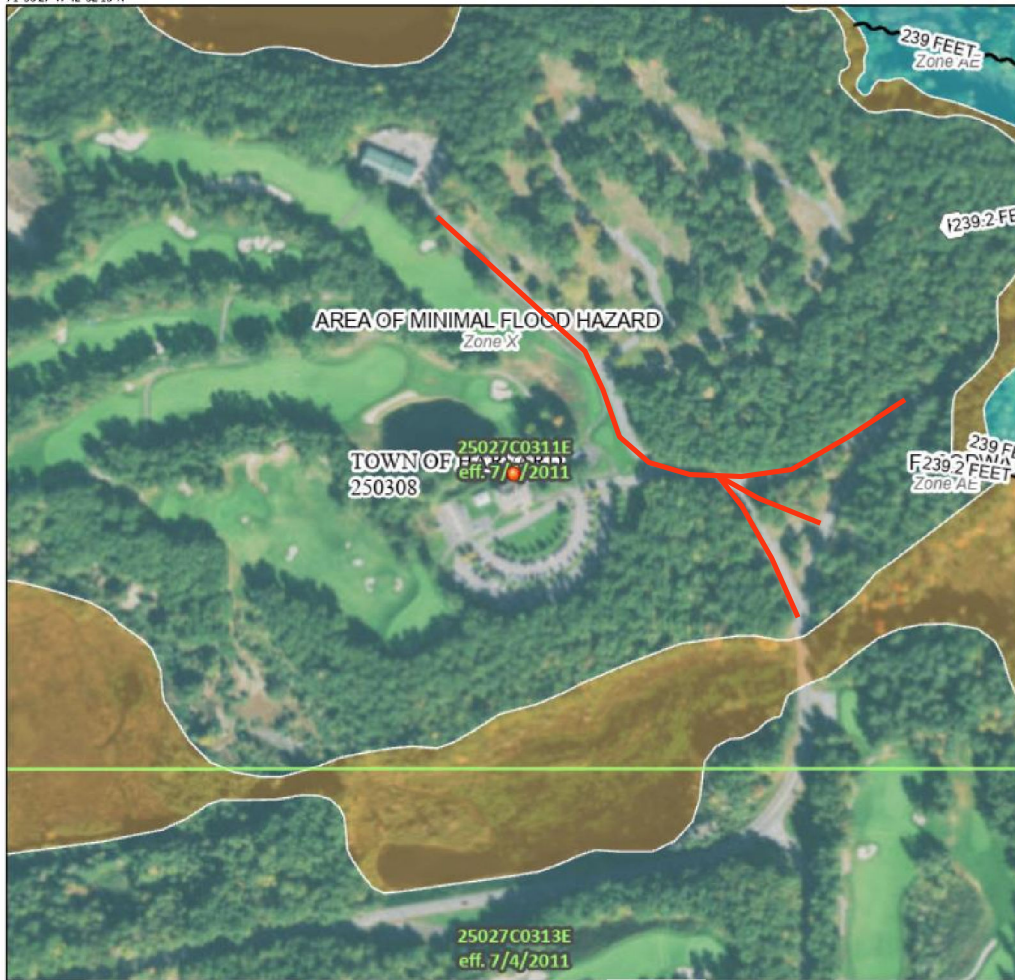
The pin displayed on the map is an approximate point selected by the user and does not represent an authoritative property location.

0 250 500 1,000 1,500 2,000 Feet

Basemap: USGS National Map: Orthoimagery; Data refreshed October, 2020
